Inspection Report

Property Address:
7701 Sample Ave
Las Vegas NV 89131

Dodson Inspections LLC

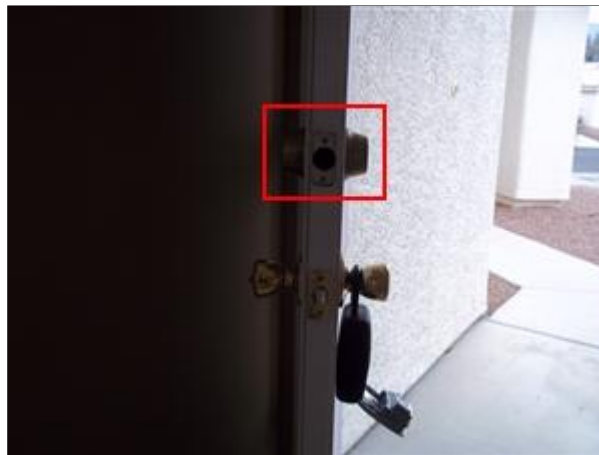
2.1 Picture 1

(1) Front door dead bolt lockset is damaged. Recommend replacing or repairing for proper security.

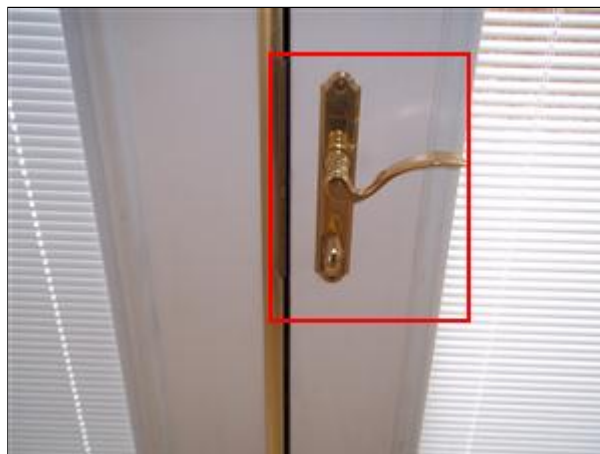
2.1 Picture 2

(2) Lockset on back french door is damaged and will not lock. Handle on exterior is also damaged. Recommend repairs for proper security.

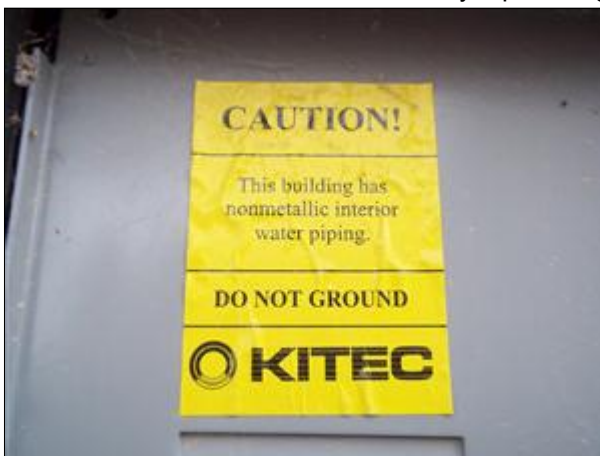
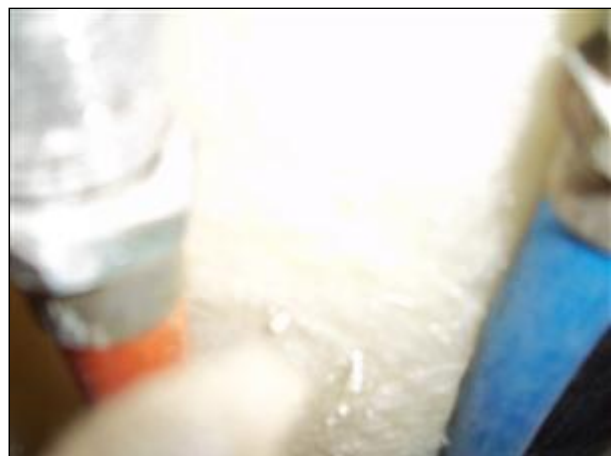
4.1 Picture 1

(1) Interior water supply piping is KITEC. This type of plumbing supply has been known to cause plumbing problems in many homes. Recommend further evaluation by a plumbing contractor.

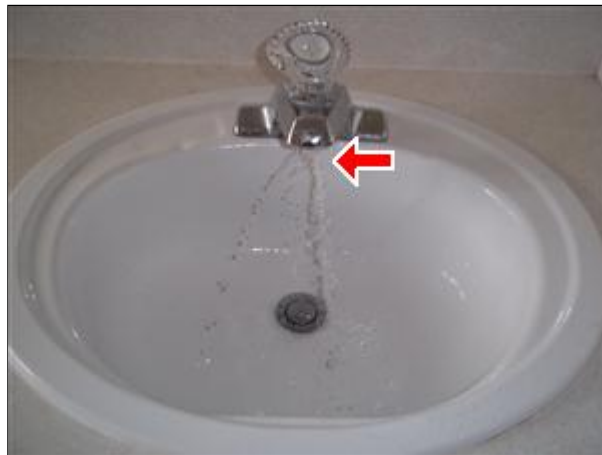
4.1 Picture 3

(2) Master bathroom sink faucet does not distribute water properly. (As shown in picture) Recommend repairs by a licensed plumber.

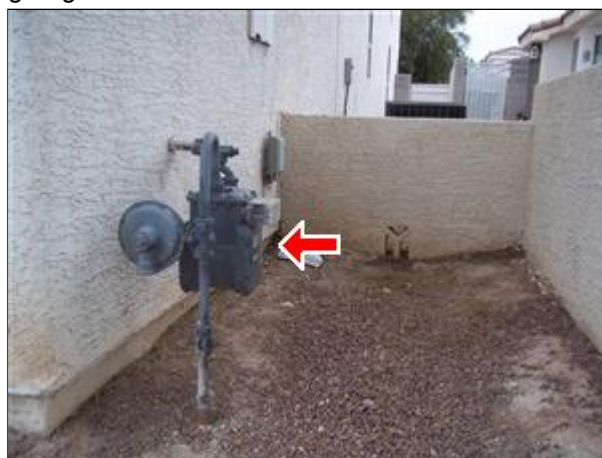
4.8 Picture 1

Located on the exterior wall of the garage.

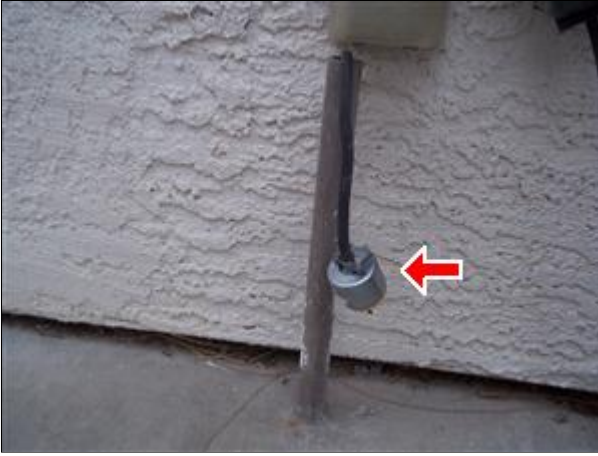
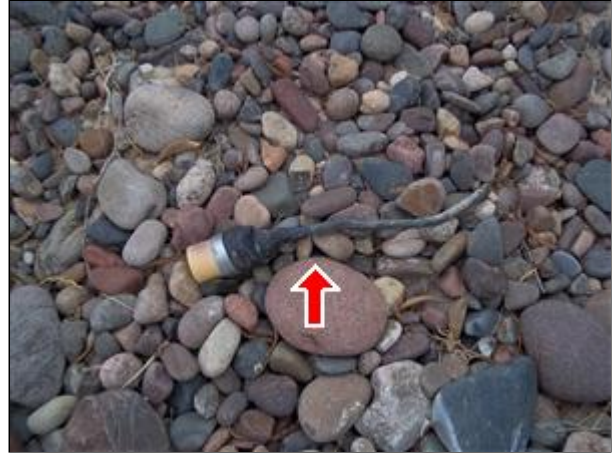
5.9 Picture 1

Recommend removal of the electrical chord ran from exterior outlet to landscape rocks. Electrical chord can be exposed to water and is a safety issue.

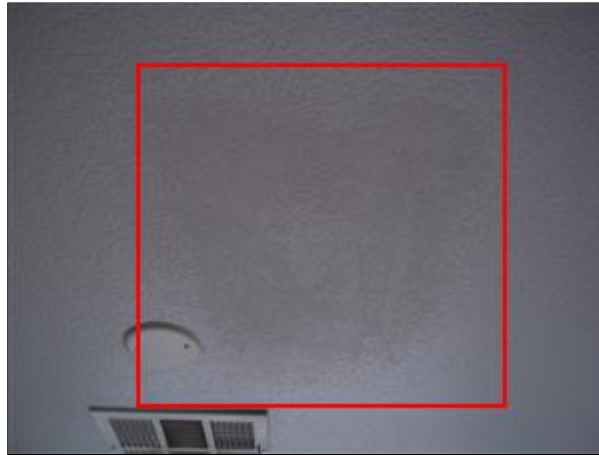
8.0 Picture 1

Discolor on kitchen ceiling. Appears to be a patch repair from a previous leak (Master Bath Above Kitchen). No moisture was present. Recommend monitoring.

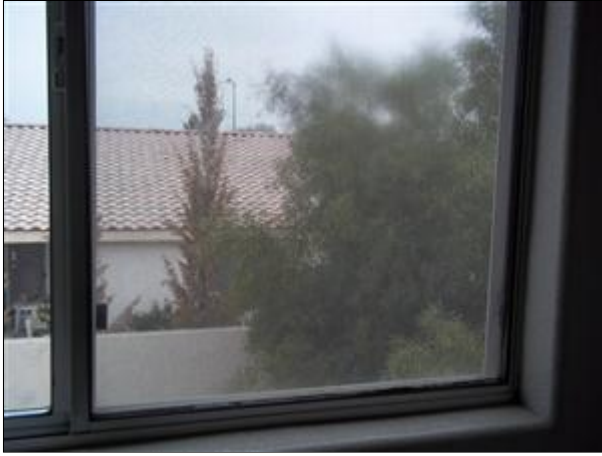
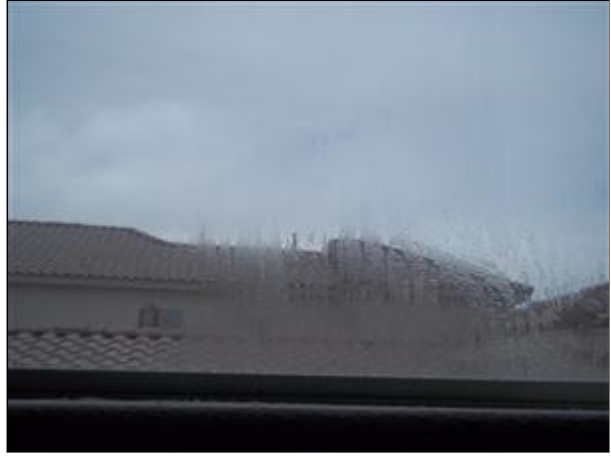
8.5 Picture 1

Thermal seals inside windows are broken causing windows throughout home to have condensation in between the glass panes.

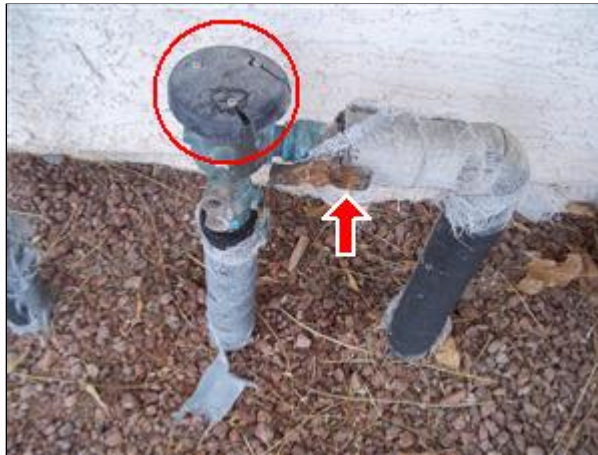
11.3 Picture 1

Vacuum breaker is cracked and leaking. Valves have signs of corrosion and should be replaced. Recommend repairs by a licensed contractor.

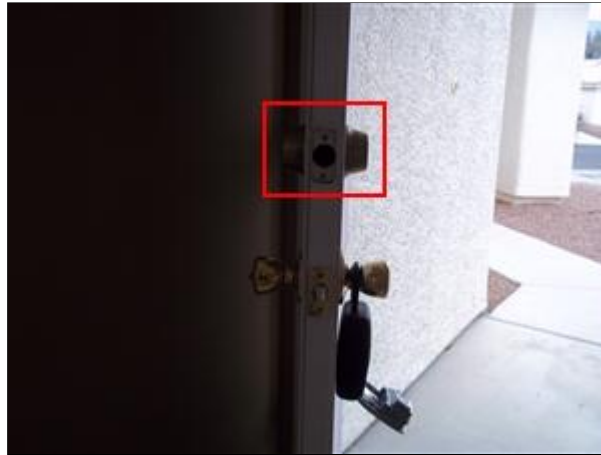
2.1 Picture 1

(1) Front door dead bolt lockset is damaged. Recommend replacing or repairing for proper security.

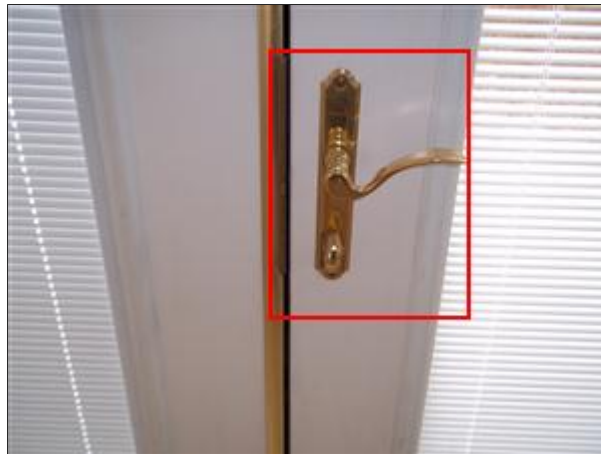
2.1 Picture 2

(2) Lockset on back french door is damaged and will not lock. Handle on exterior is also damaged. Recommend repairs for proper security.

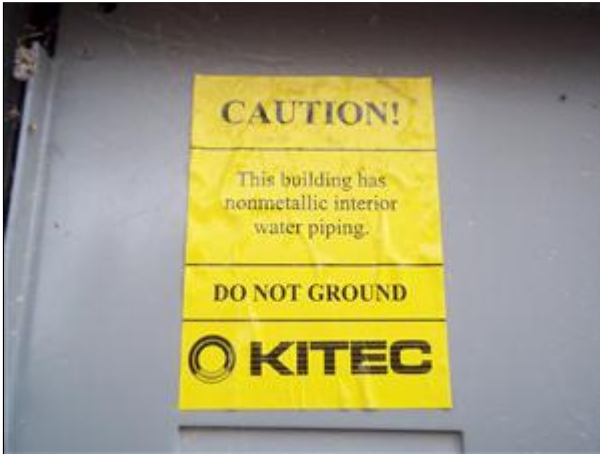
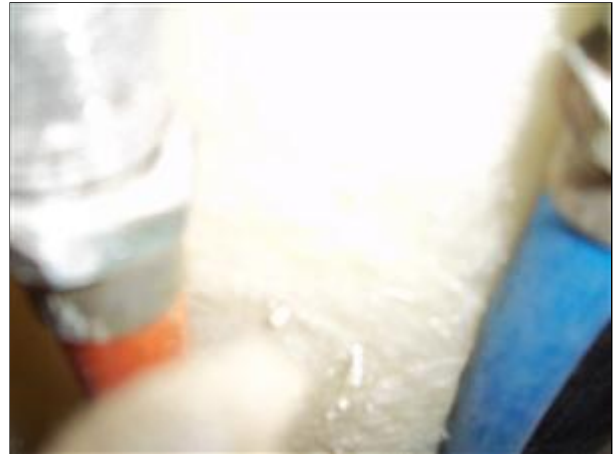
4.1 Picture 1

(1) Interior water supply piping is KITEC. This type of plumbing supply has been known to cause plumbing problems in many homes. Recommend further evaluation by a plumbing contractor.

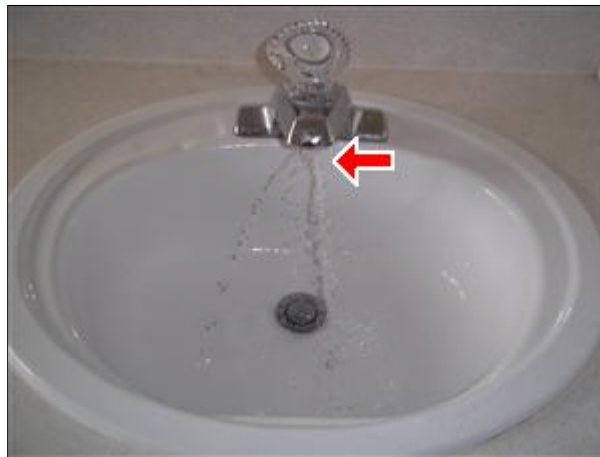
4.1 Picture 3

(2) Master bathroom sink faucet does not distribute water properly. (As shown in picture) Recommend repairs by a licensed plumber.

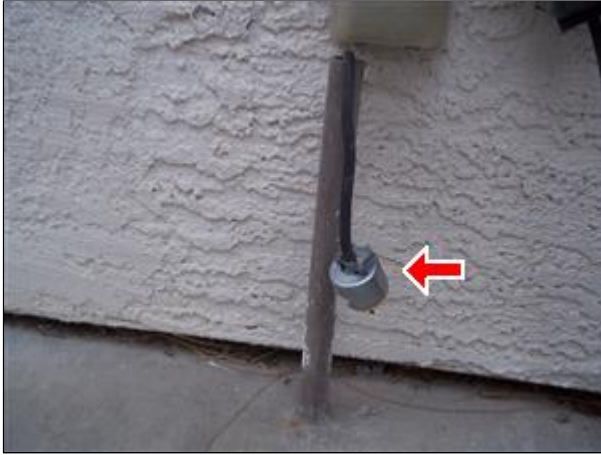
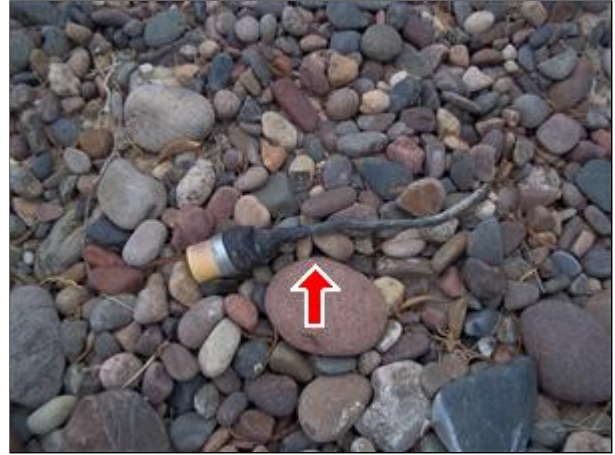
5.9 Picture 1

Recommend removal of the electrical chord ran from exterior outlet to landscape rocks. Electrical chord can be exposed to water and is a safety issue.

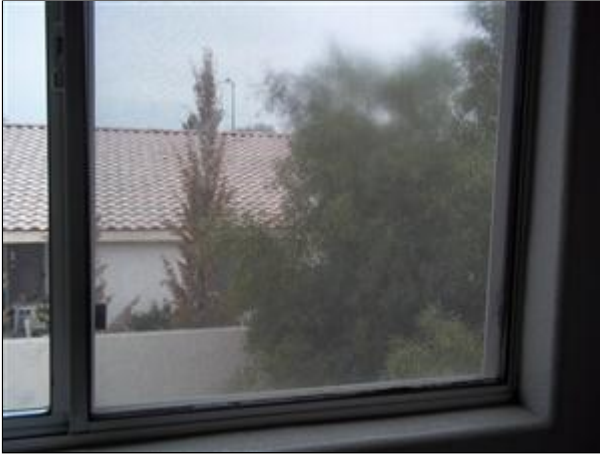
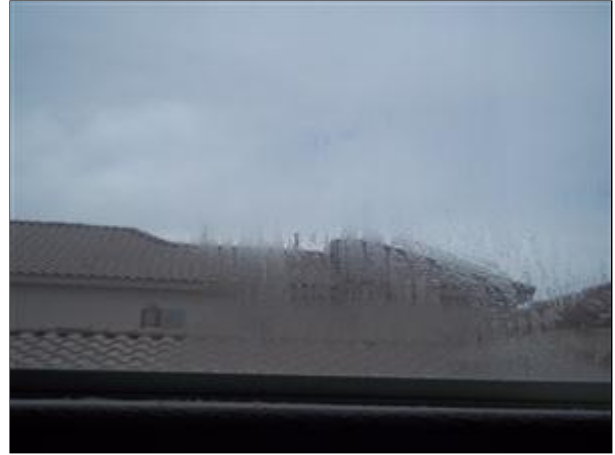
8.5 Picture 1

Thermal seals inside windows are broken causing windows throughout home to have condensation in between the glass panes.

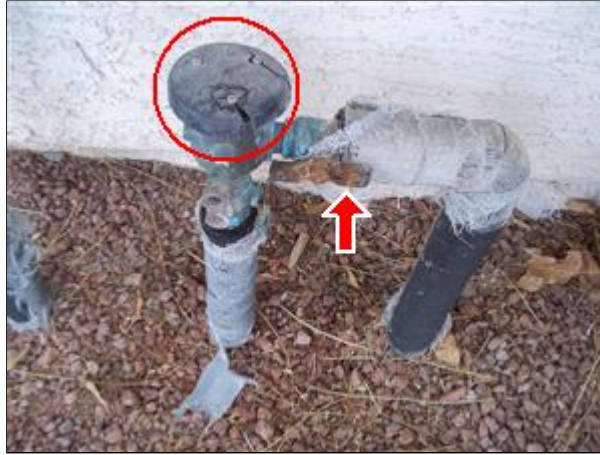
11.3 Picture 1

Vacuum breaker is cracked and leaking. Valves have signs of corrosion and should be replaced. Recommend repairs by a licensed contractor.
